TEST REPORT

Fire resistance load-bearing test of a 136mm thick Ozone Panels wall system tested in accordance with AS 1530.4 – 2005.

2758400

22nd August 2012

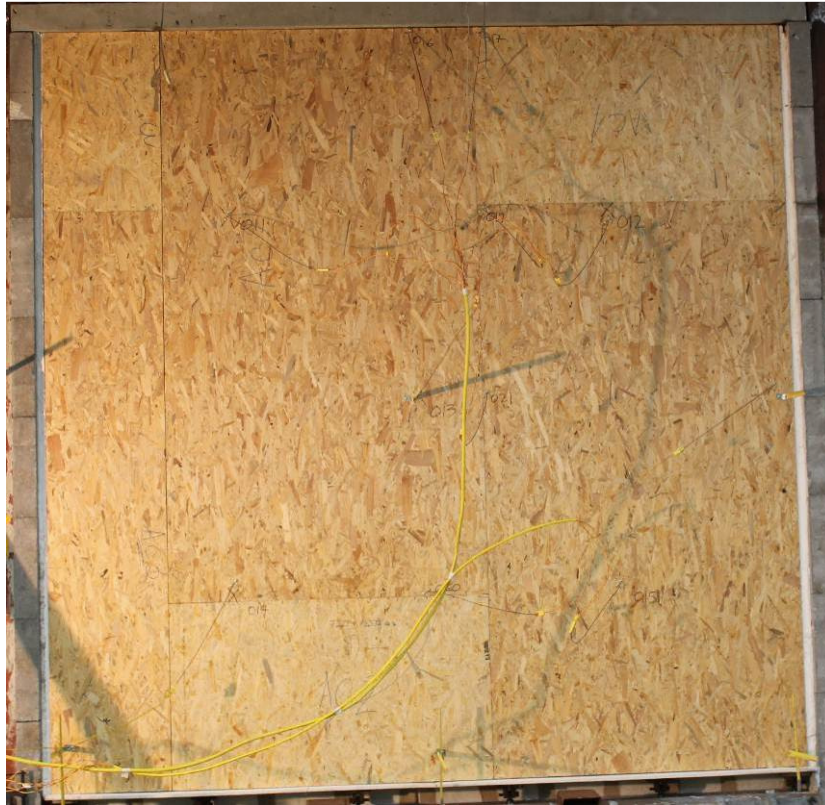
Figure A6.1. Unexposed face of specimen before commencement of the fire-resistance test.

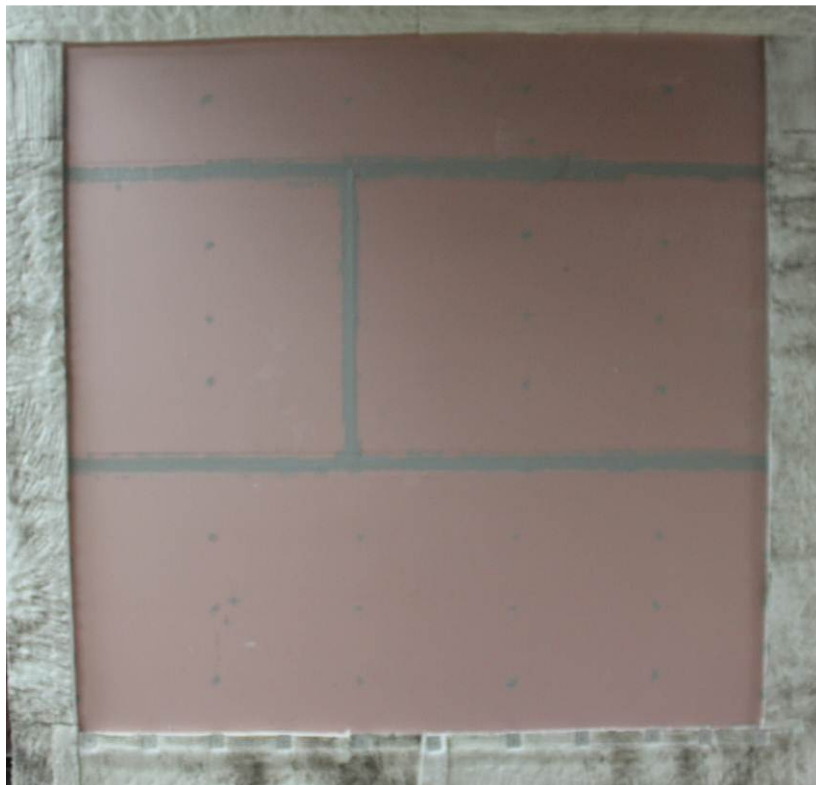
Figure A6.2. Exposed face of specimen before commencement of the fire-resistance test.

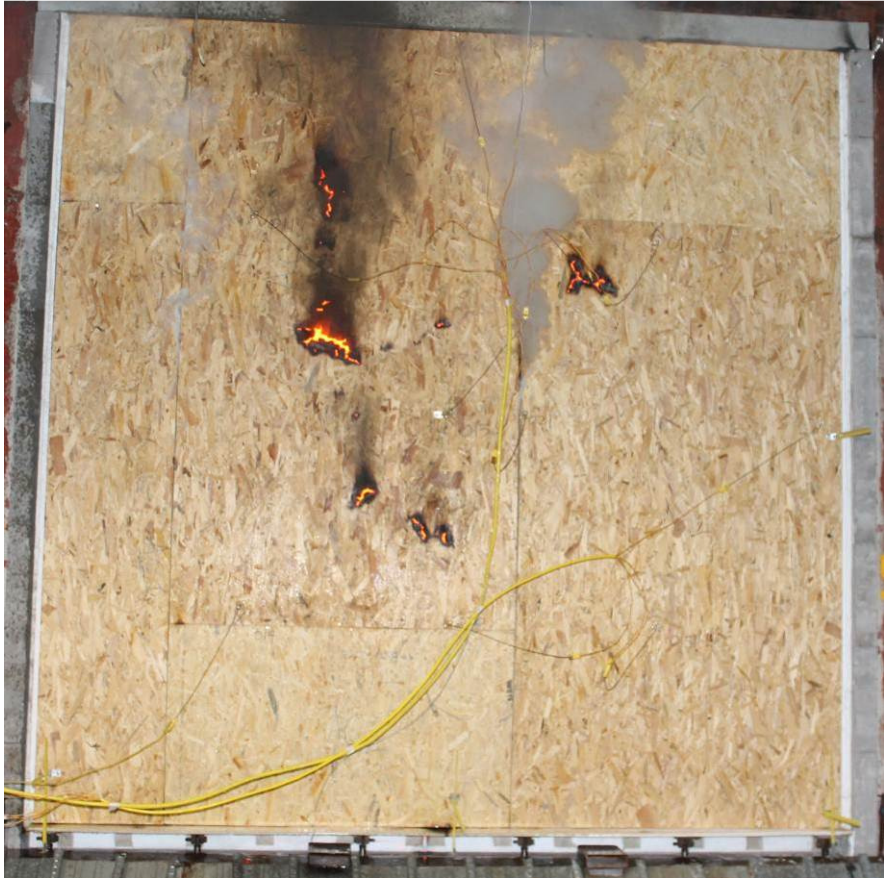
66	00	Slight discolouration on the specimen in the path of the smoke.
77	00	A 90 second roving thermocouple test was carried out near the aperture that had become evident towards the centre of the specimen, resulting in a temperature of 250°C. Failure on insulation in accordance with AS 1530.4-2005, clause 2.12.3(b), where the temperature exceeded the initial temperature by more than 180°C
80	00	Another aperture had become evident on the surface of the wall approximately 300mm below the first aperture.
81	00	Flaming at the aperture towards the centre of the specimen had become evident. Failure on integrity in accordance with AS 1530.4-2005, clause 2.12.2.4, due to sustained flaming on the non-exposed side for greater than 10 seconds.
83	00	Two more apertures had become evident on the surface of the wall.
85	00	Test terminated at the request of the sponsor.

Figure A6.3. Unexposed face of specimen at the end of the test

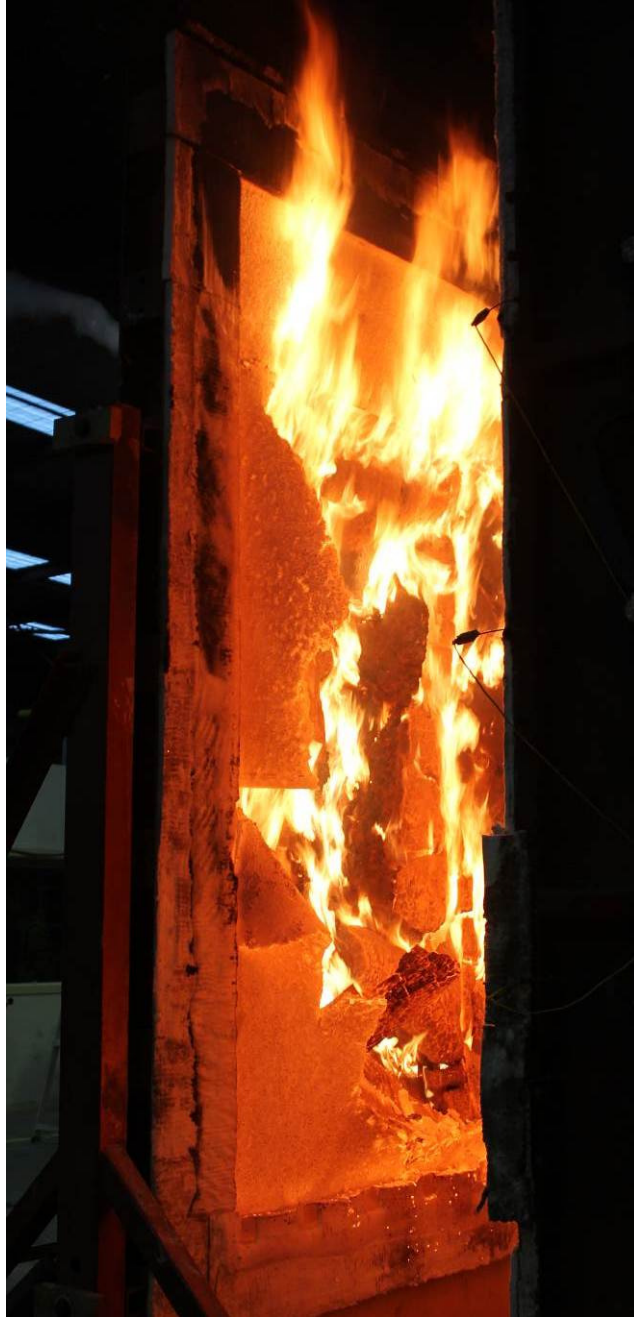
Figure A6.4 Exposed face of specimen at the end of the test
